RE: Site Inspection, Blue Castle Mine, Gold Terra, Inc., S/015/077, Emery County, Utah

Date of Inspection: August 8, 2003
Time of Inspection: 9:30 a.m.- 9:50 a.m.
Conditions: Sunny and warm
Participants: Wayne Hedberg, Susan White, Joelle Burns, DOGM

Purpose of Inspection: To check status of Division requested pit highwall regrading actions by the operator.

S/015/077, Blue Castle Mine, Goldterra, Inc.

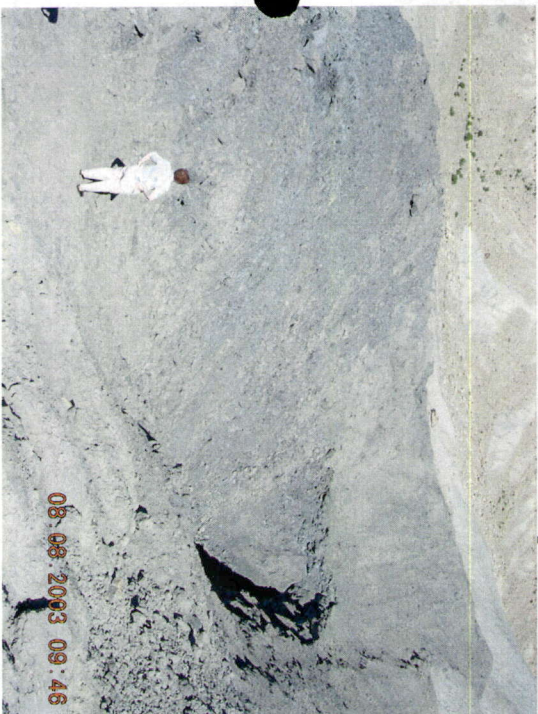
Photo 1 - NW View of Existing Pit (shows resloped edges to allow egress)

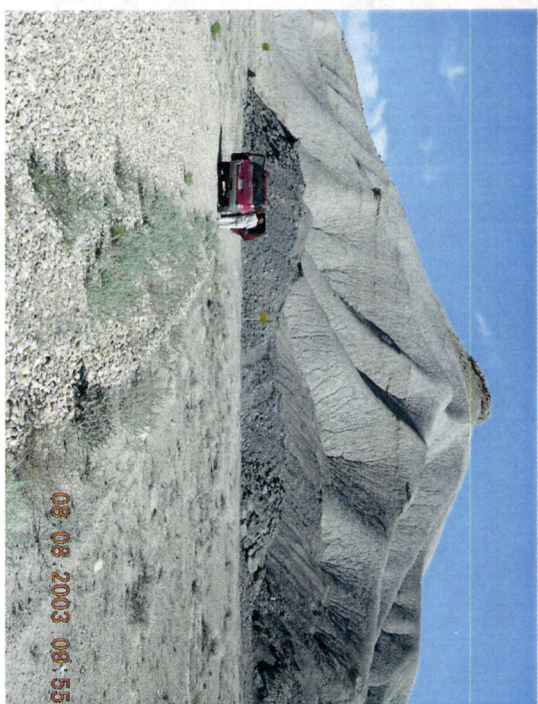
Photo 3 - Overview of Mine Area Disturbance

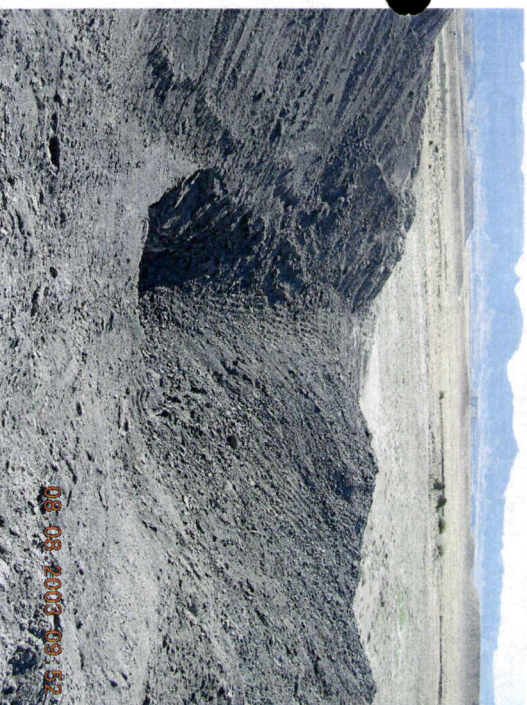
Photo 2 - Existing Pit (View looking SE from behind highwall)

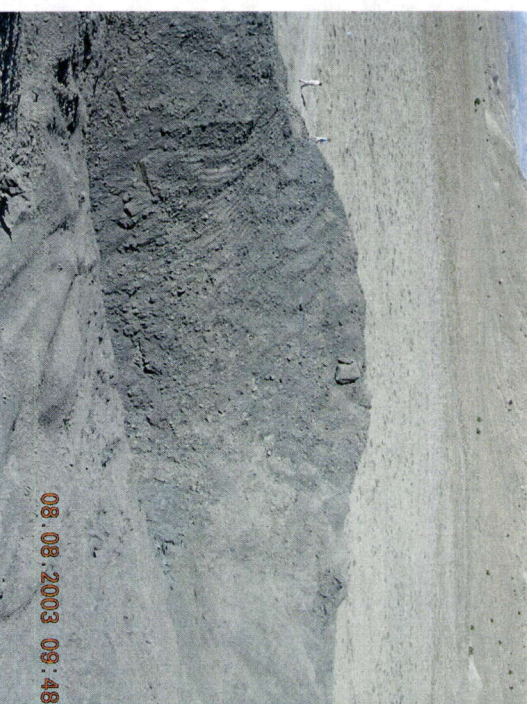
Photo 4 - Central Pit view from SE

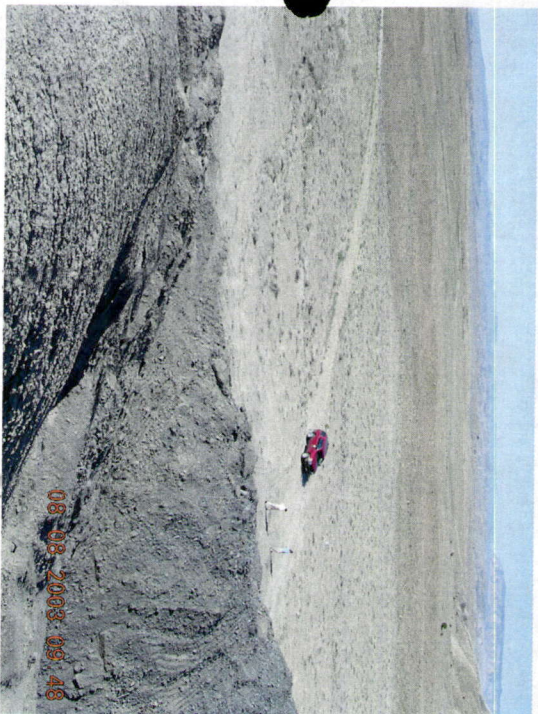
Photo 5 - SE end view of Pit and main access road

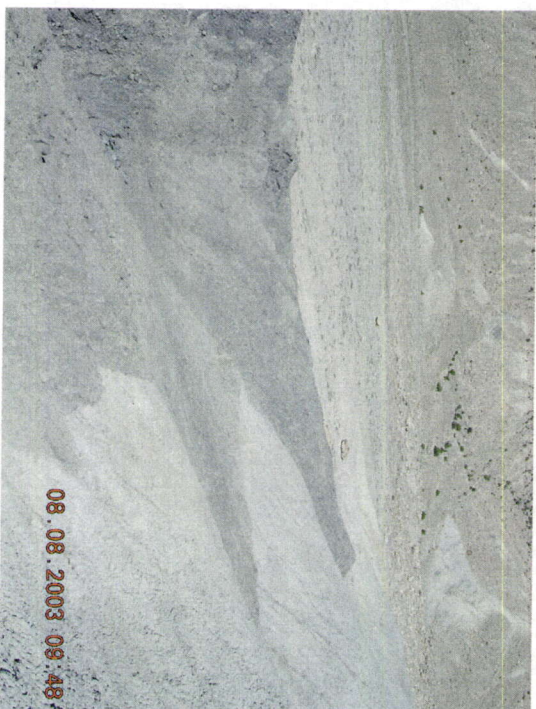
Photo 6 - View of NW end of Pit
